USAAVSCOM TR 89-D-21

**OPERATIONAL EFFECTS ON CRASHWORTHY  
SEAT ATTENUATORS**

**Marvin Kent Richards**

**Final Report for Period September 1987 - November 1989**

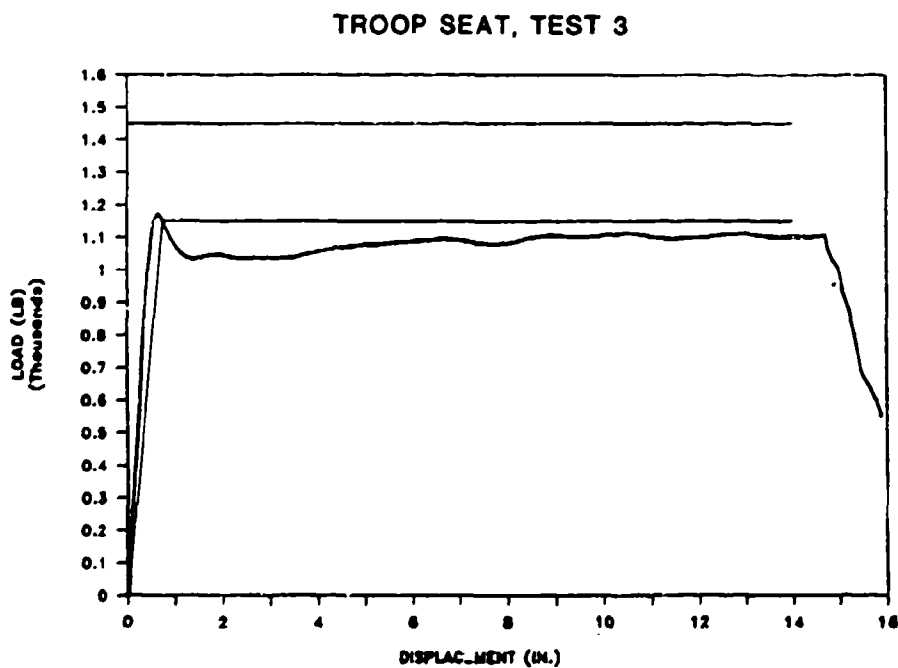
An example of a typical static test result for a new troop seat energy absorber is shown in Figure 8. The load peaked out at approximately 1170 lb and then dropped to a relatively steady load around 1070 lb, well below the desired minimum of 1150 lb. This response was similar for all four of the new energy absorbers, which had an average stroking load between 1059 and 1078 lb. Plots for the other three energy absorbers can be found in Appendix B.

**FIGURE 8. TYPICAL STATIC TEST RESULT - TROOP SEAT, NEW ENERGY ABSORBER.**

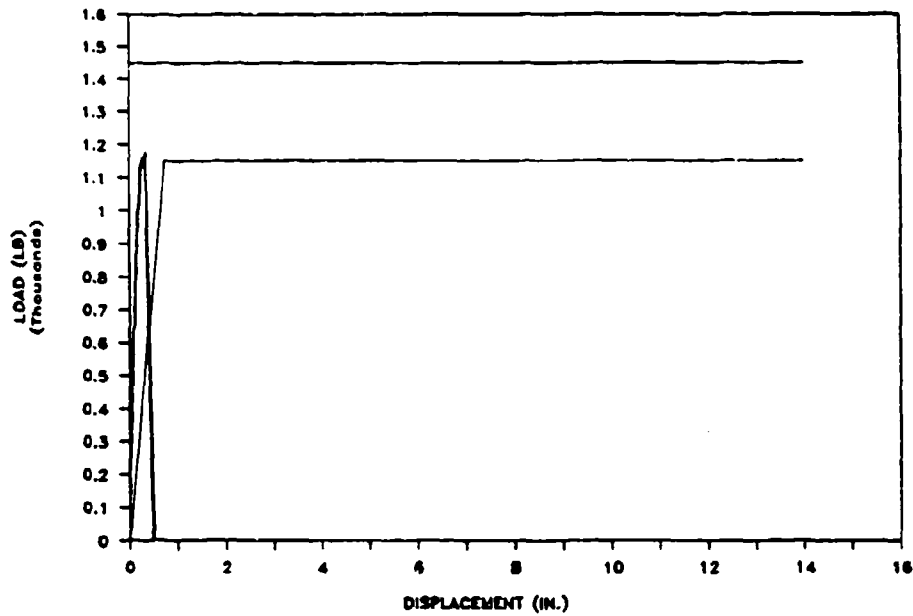
TROOP SEAT, T/N 77-22720, SEAT 1

Two fielded energy absorbers from the same troop seat failed. Figure 9a shows the load-versus-displacement plot for one which failed at 1174 lb. The other energy absorber that failed (plot not shown) broke at 1087 lb. The two energy absorbers broke at the same location where the wire is suspended, as shown in Figure 10.

FIGURE 9. TYPICAL STATIC TEST RESULTS - TROOP SEAT, FIELDED ENERGY ABSORBER.

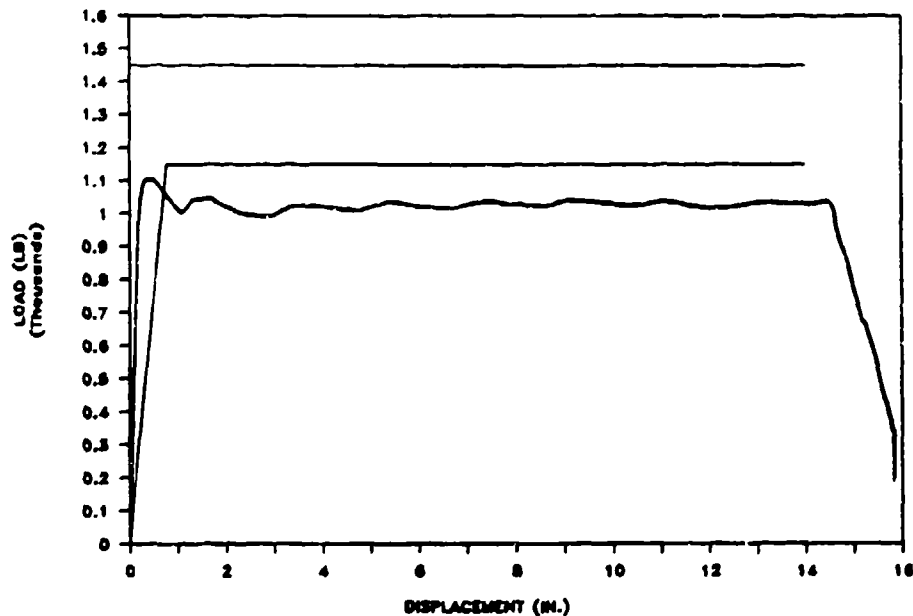
TROOP SEAT , T/N 78-22971, SEAT 1

Two of the energy absorbers stroked. Figure 9b shows a load-versus-displacement curve for one which stroked at an average load of 1024 lb. The other energy absorber (plot not shown) stroked at an average load of 1009 lb.

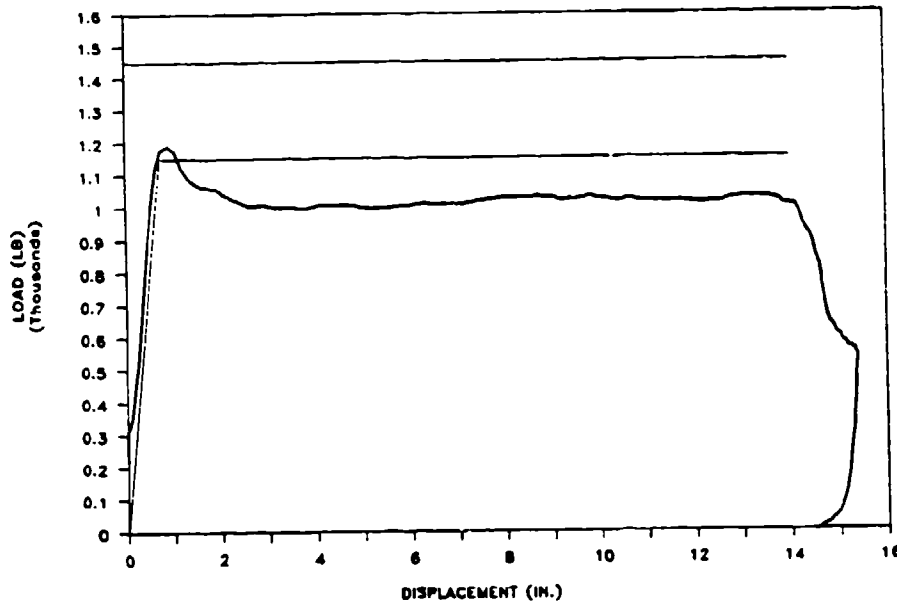
An example of a new troop seat energy absorber dynamic test result is shown in Figure 13. Plots for the other five energy absorbers can be found in Appendix B. The load-deflection characteristics were similar to those for the static tests.

**FIGURE 13. TYPICAL DYNAMIC TEST RESULT - TROOP SEAT, NEW ENERGY ABSORBER.**

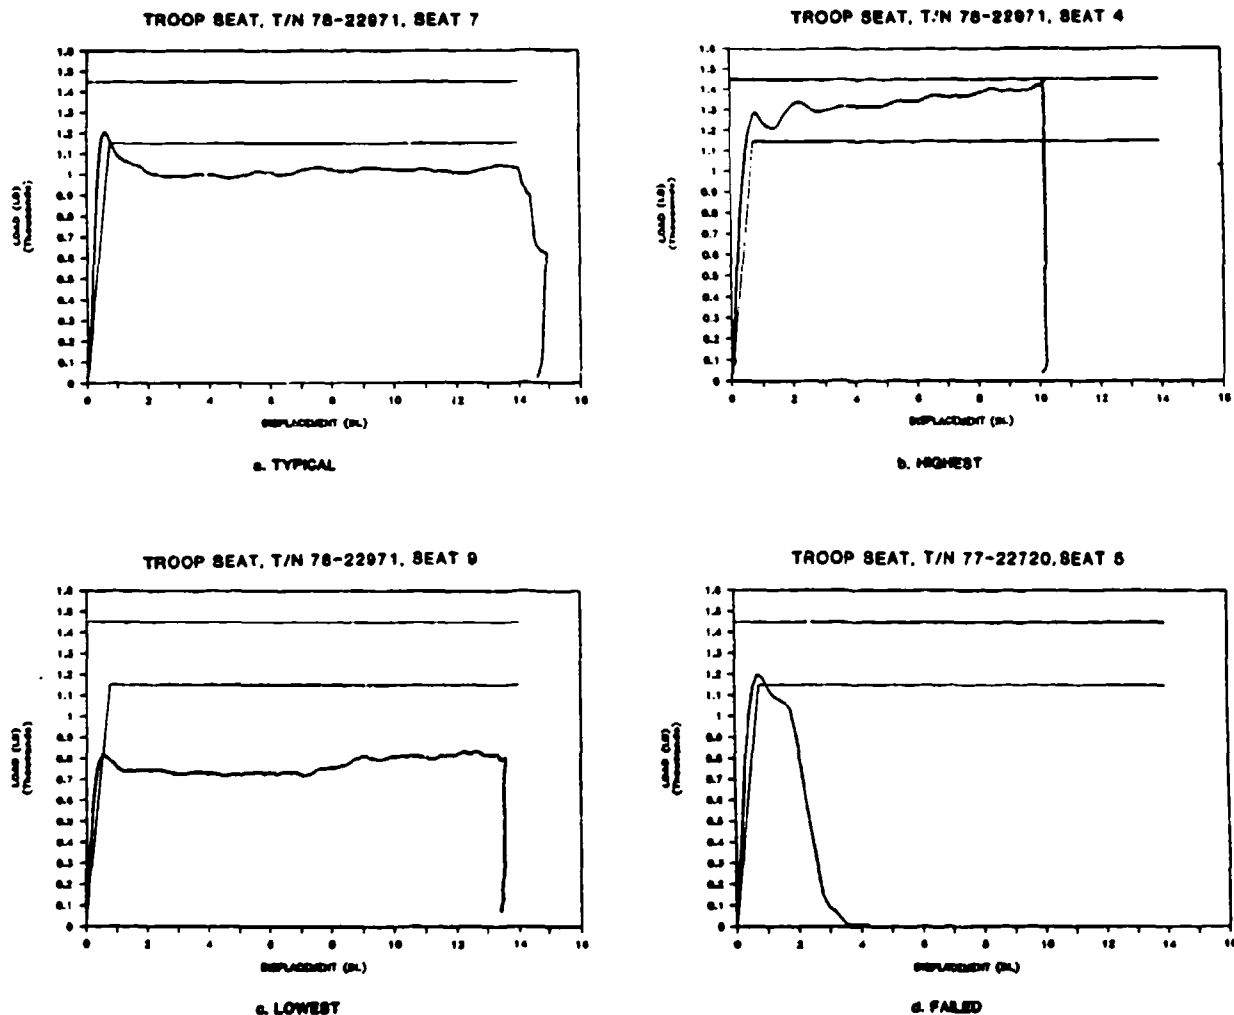
Test result examples are presented in Figure 14. Twenty-two of 24 energy absorbers that stroked gave load-deflection characteristics similar to those shown in Figure 14a, with the average stroking load ranging between 942 and 1068 lb. Characteristics of the other two energy absorbers were relatively high and low. The plot for the highest energy absorber, which had an average load of 1302 lb, is shown in Figure 14b. This is the only energy absorber that stroked within the specified load limits. This energy absorber stopped short due to insufficient input energy from the dynamic test apparatus. Note that the load was continually increasing and may have exceeded the load-limit had stroke continued. Figure 14c shows the plot for the lowest energy absorber, which had an average stroking load of 757 lb.

The remaining 20 energy absorbers failed with similar load-deflection characteristics as those shown in Figure 14d. Plots of the remaining energy absorbers can be found in Appendix B.

**FIGURE 14. TYPICAL DYNAMIC TEST RESULTS - TROOP SEAT, FIELDED ENERGY ABSORBERS.**

All dynamic failures occurred where the wire wraps around the rollers, indicating that the load distributing saddles were not a factor (11 broke with the saddle, 12 without). None of the new energy absorbers failed. The average load of new energy absorbers were only slightly higher (2.6 percent) than the fielded energy absorbers that did not fail. The energy absorbers consistently stroked approximately 280 lb under the desired nominal load of 1300 lb, with the exception of aircraft 78-22971 (seats 4a and 9b), which stroked at an average load of 1302 and 757 lb, respectively.

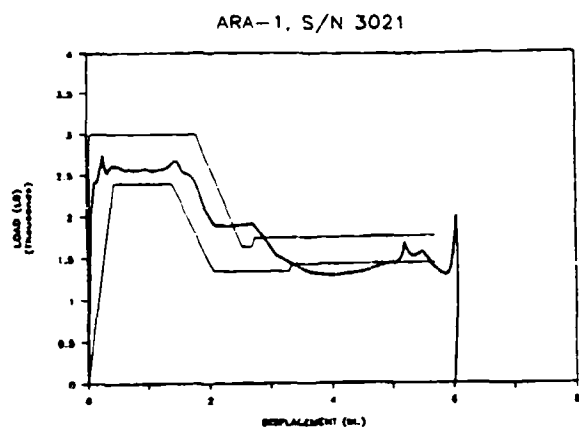
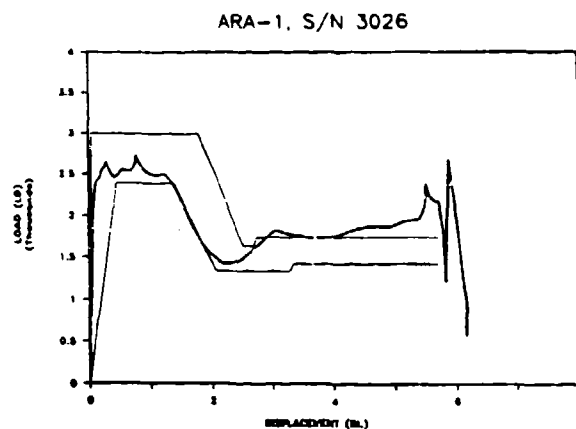
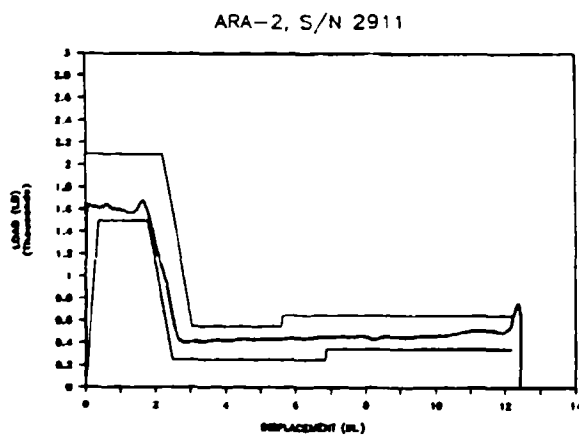
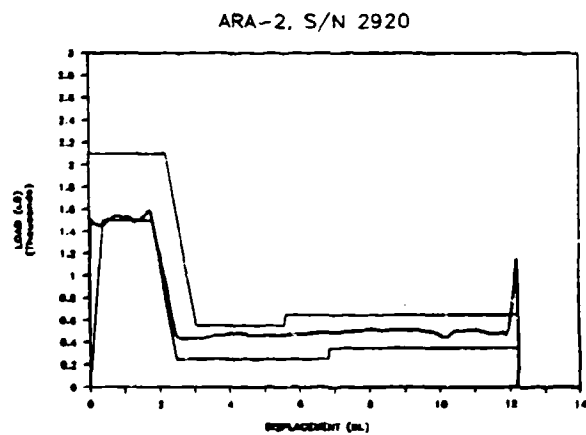
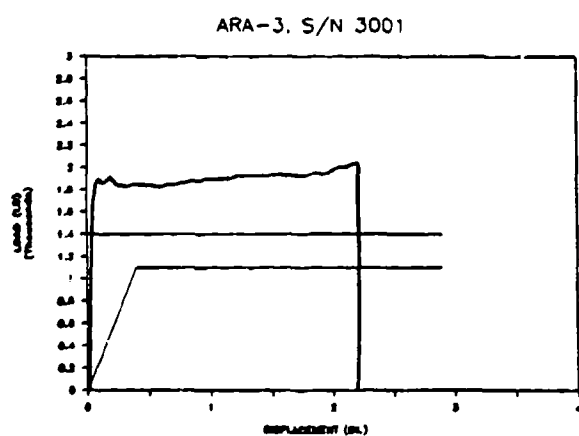
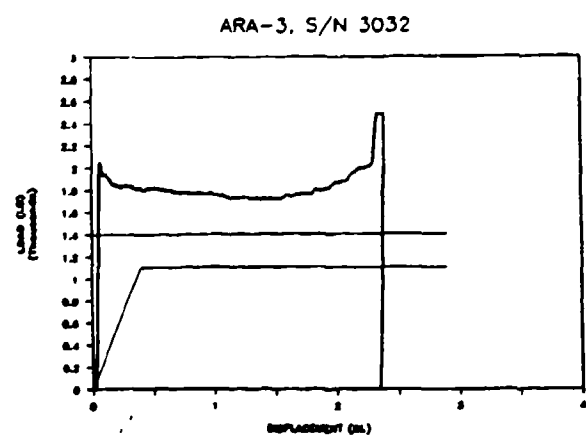
Plots of the static test results for the new ARA energy absorbers are shown in Figure 20. The -1 and -3 energy absorbers did not fall within the specified limits for the entire stroke. The -3 energy absorbers were both high, and one -1 was high and the other low at the end of the stroke. Both -2 energy absorbers met the desired load-deflection characteristics.

**FIGURE 20. STATIC TEST RESULTS - ARA CREW SEAT,  
NEW ENERGY ABSORBERS.**

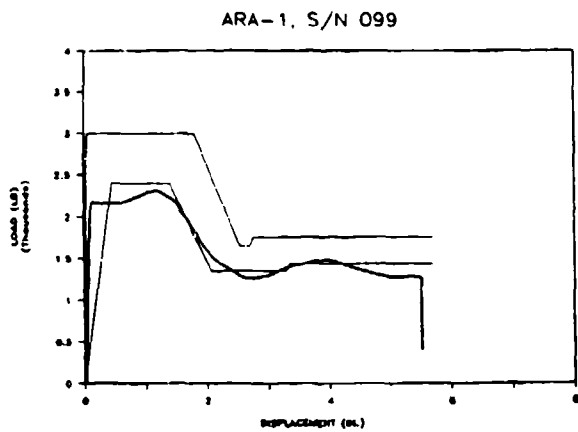
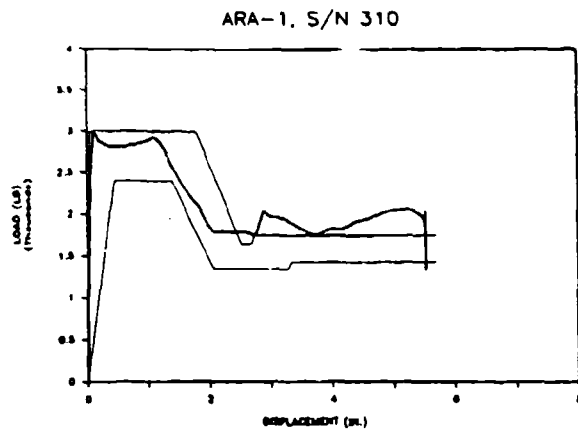
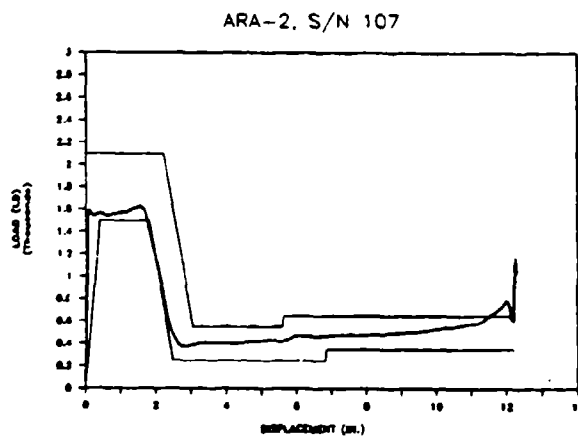
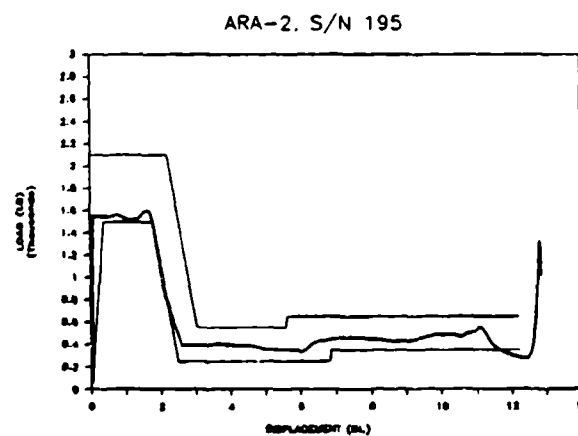
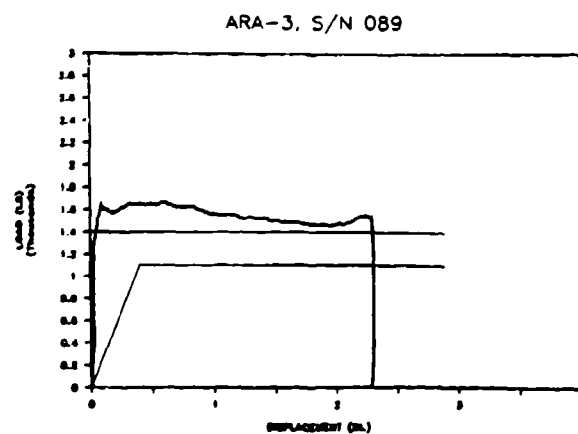
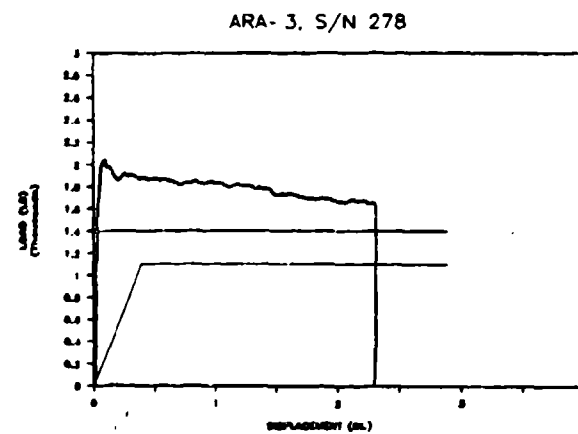
Plots of the static test results for the fielded ARA energy absorbers are shown in Figure 21. The load-deflection response of the fielded units was similar to that of the new units in that both -3 energy absorbers were high, and one -1 was high and the other low at the end of stroke. Both -2 energy absorbers met the specified load-deflection requirements.

**FIGURE 21. STATIC TEST RESULTS - ARA CREW SEAT, FIELDIED ENERGY ABSORBERS.**

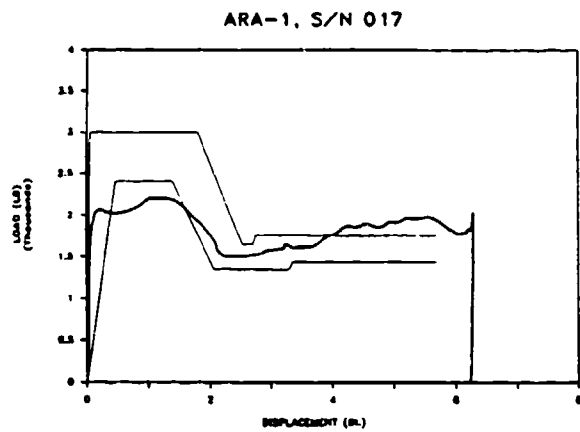
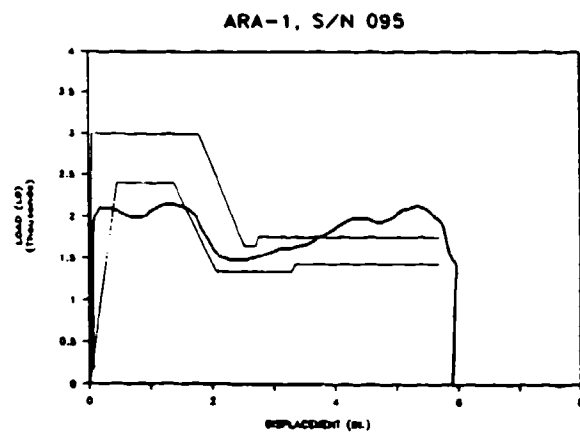
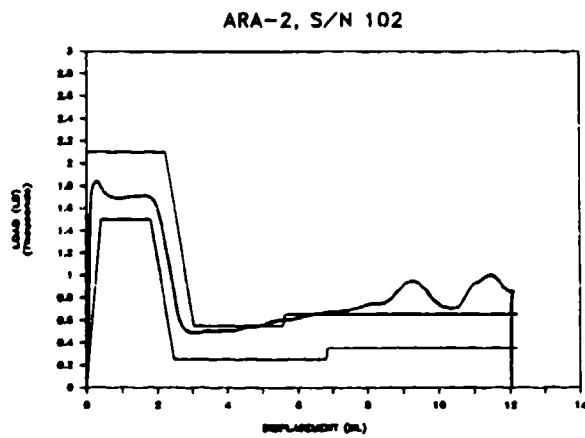
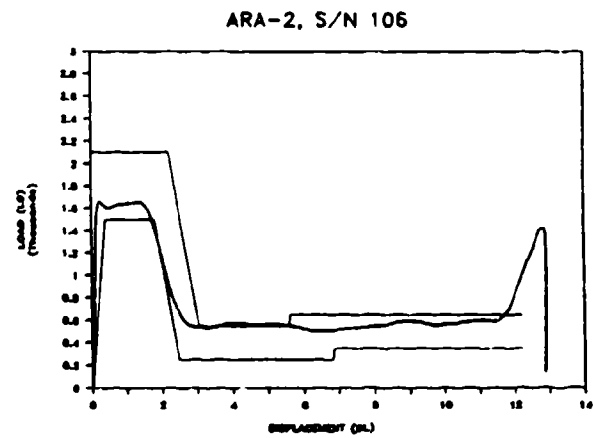
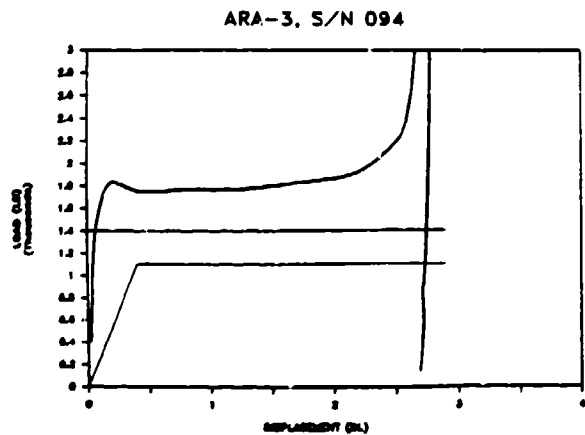
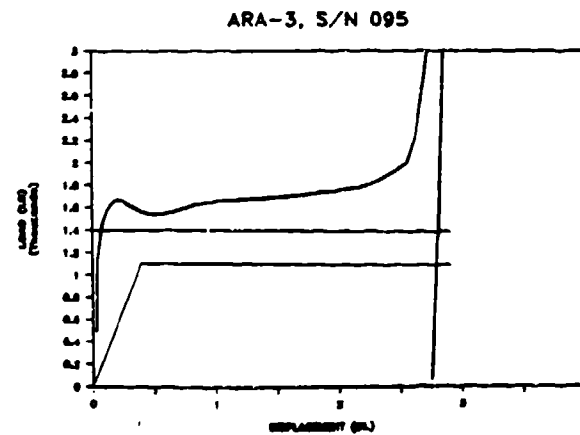
Examples of dynamic test results for the fielded ARA energy absorbers are shown in Figure 23. In general the dynamic response of the fielded energy absorbers was similar to that of the new energy absorbers. Selected worst-case examples are shown in Figure 24. Plots for the remaining fielded energy absorbers can be found in Appendix C.

**FIGURE 23. TYPICAL DYNAMIC TEST RESULTS - ARA CREW SEAT, FIELDIED ENERGY ABSORBERS.**

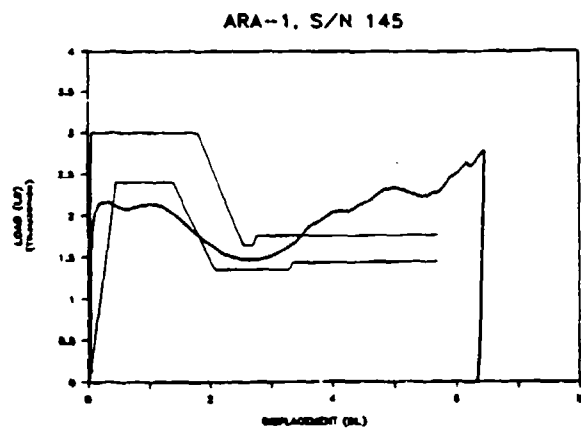
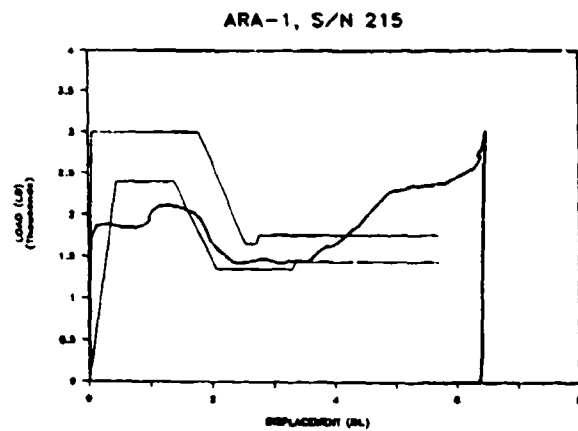
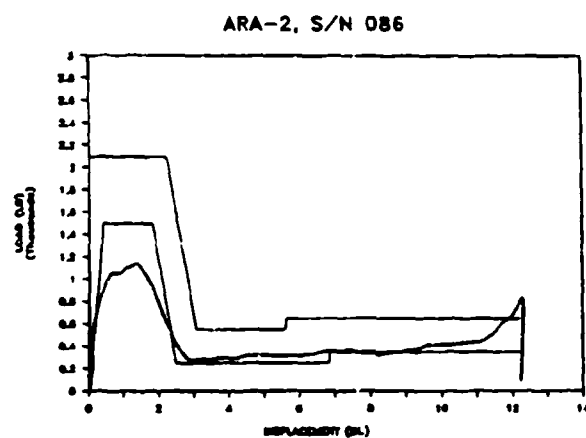
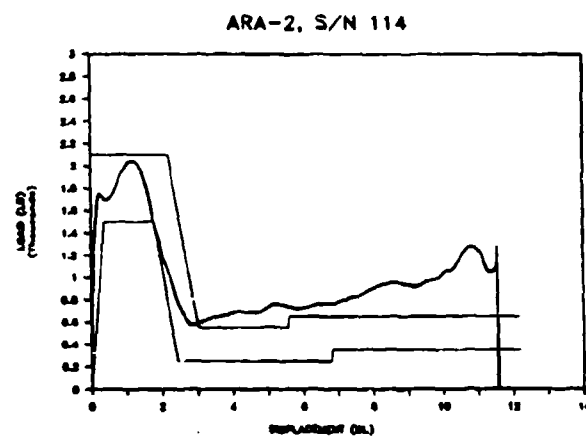
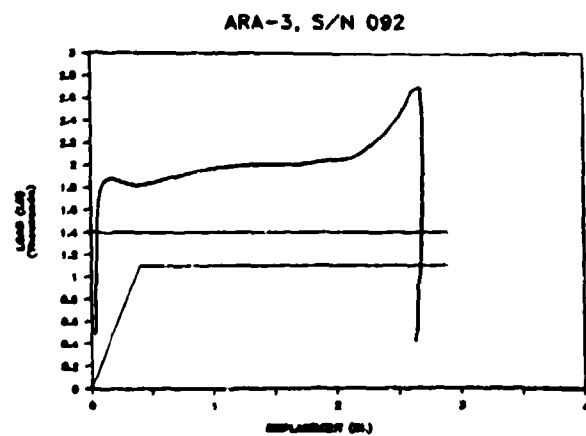
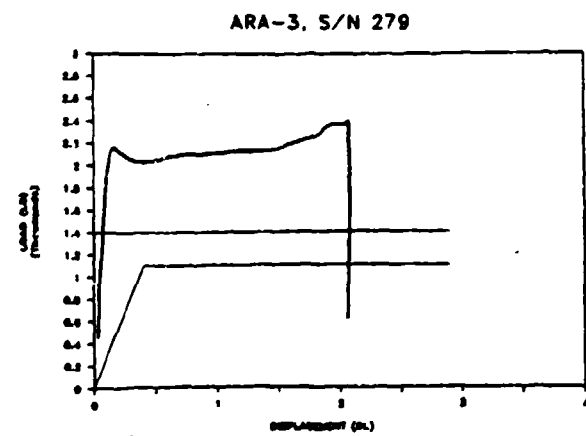
**FIGURE 24. WORST-CASE DYNAMIC TEST RESULTS - ARA CREW SEAT, FIELDIED ENERGY ABSORBERS:**

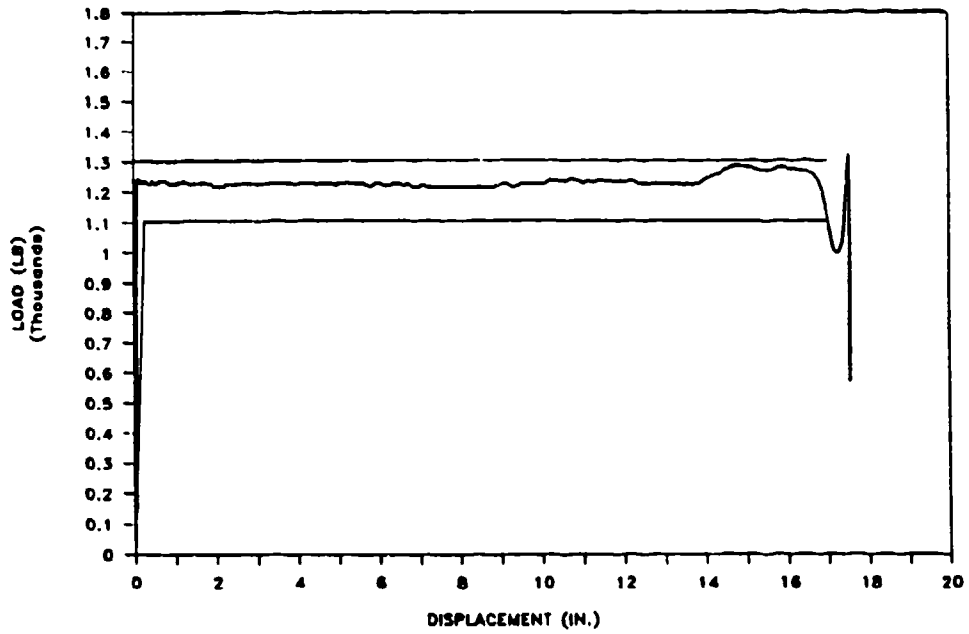
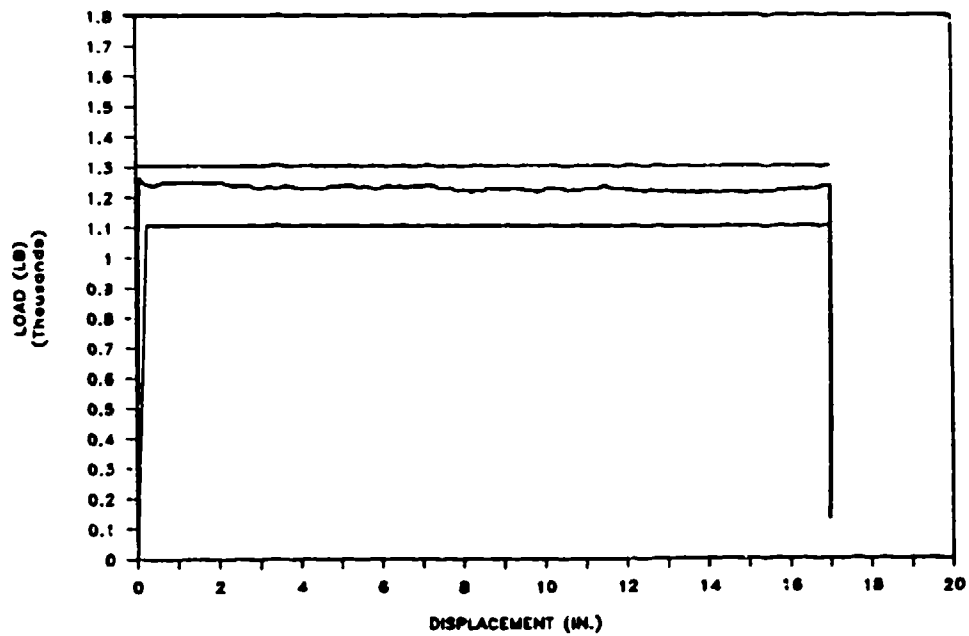
Plots of the static test results for the fielded Simula/Norton energy absorbers are shown in Figure 28. Both energy absorbers stroked within the desired corridor. Energy absorber S/N 014 had a slight load increase at the end of the stroke which was caused by the inversion tube rubbing on the housing.

FIGURE 28. STATIC TEST RESULTS - SIMULA/NORTON CREW SEAT, FIELDED ENERGY ABSORBER.

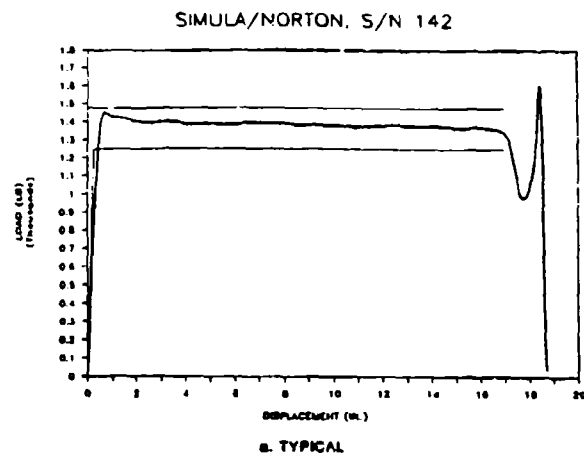
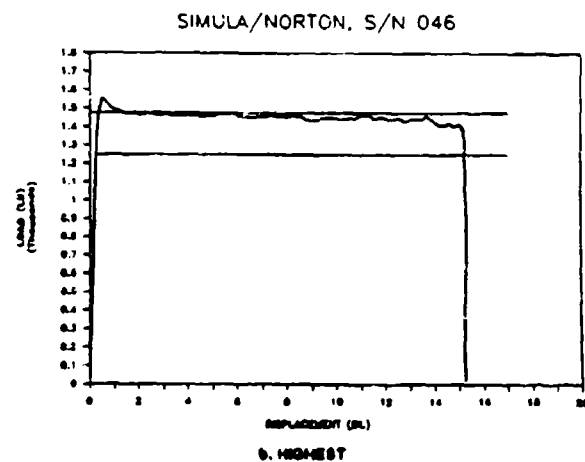
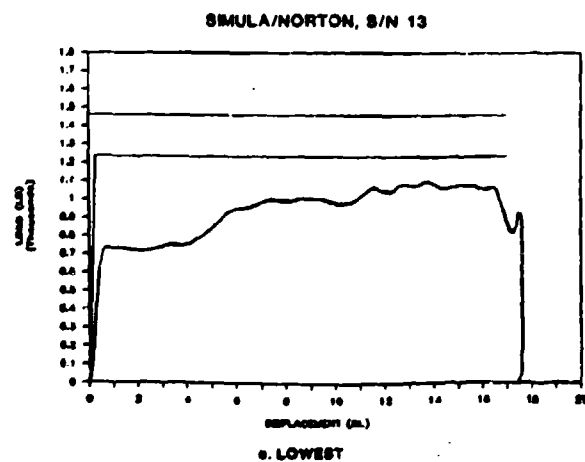
Examples of dynamic test results for the fielded Simula/Norton energy absorbers are shown in Figure 30. All of the fielded energy absorbers stroked within the desired limits except S/N 013. Energy absorber S/N 046 had the highest stroke. Note the brief initial spike outside the corridor at the

start of stroke: a total of three energy absorbers had a similar minor spike at the start of stroke. This spike was noted during seat qualification testing and is considered acceptable (Reference 1).

**FIGURE 30. DYNAMIC TEST EXAMPLES -  
SIMULA/NORTON CREW SEAT,  
FIELDED ENERGY ABSORBERS.**

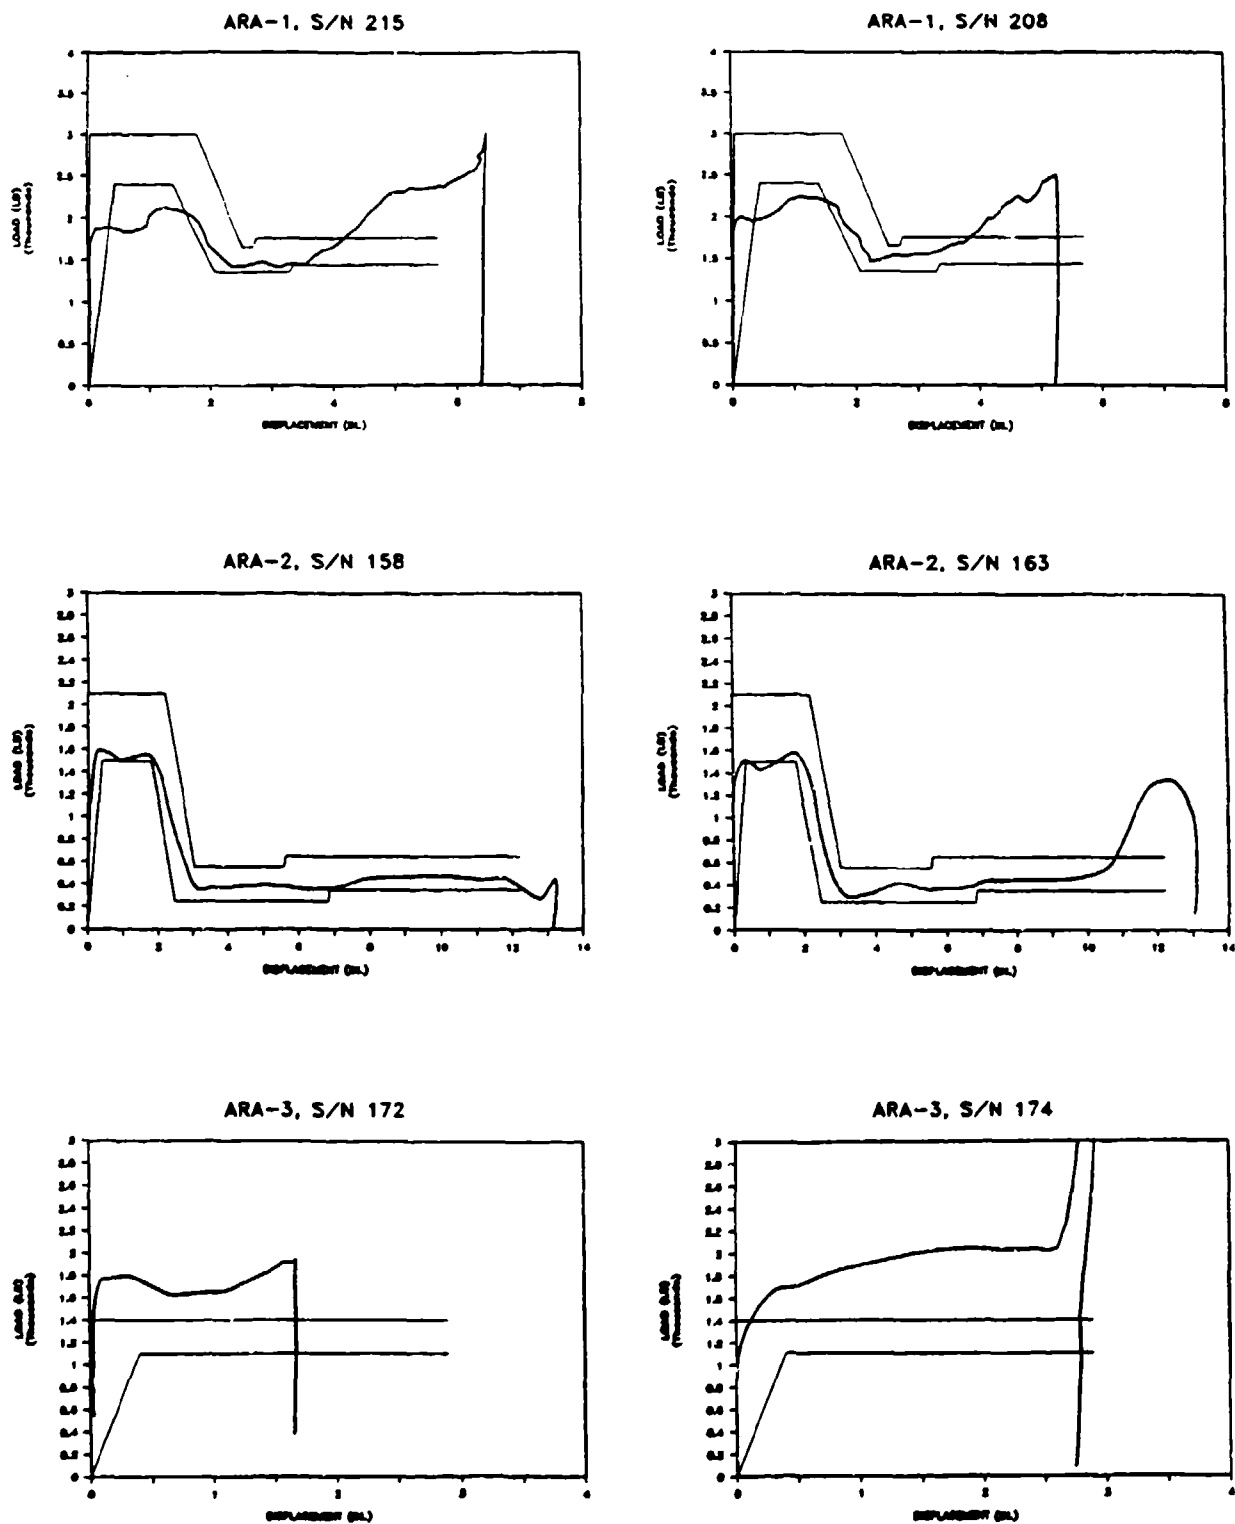
**FIGURE 42. ARA CREW SEAT HIGHEST -1 ENERGY ABSORBER LOAD-DEFLECTION CHARACTERISTICS, SEAT S/N 081, T/N 81-23619, SOH-LA MODEL 4.**

Rin No.	Maximum DR <sub>i</sub>	Maximum Spinal Load (lb)	Vertical Stroke (in.)	Description
1	42.25	2830	2.8	Theoretical nominal loads
2	39.39	2720	4.5	Lowest -2 energy absorber loads
3	42.03	2820	2.6	Highest -2 energy absorber loads
4	40.65	2759	4.0	Highest -1 energy absorber loads

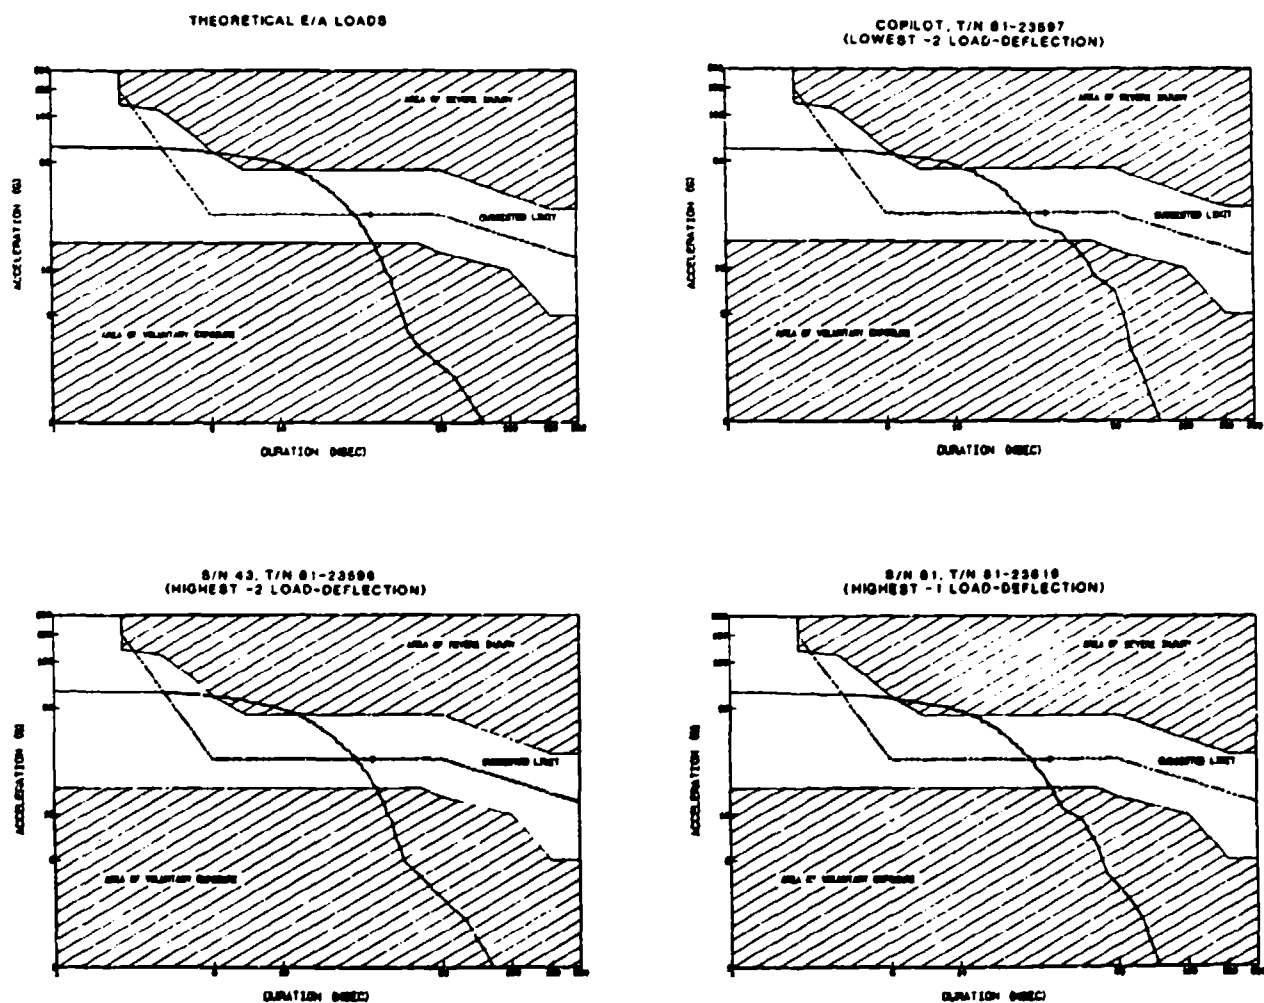
FIGURE 43. EIBAND PLOTS FOR ARA CREW SEAT SOM-LA MODEL PELVIS VERTICAL ACCELERATION.

TABLE 17. ARA CREW SEAT SOM-LA MODEL RESULTS

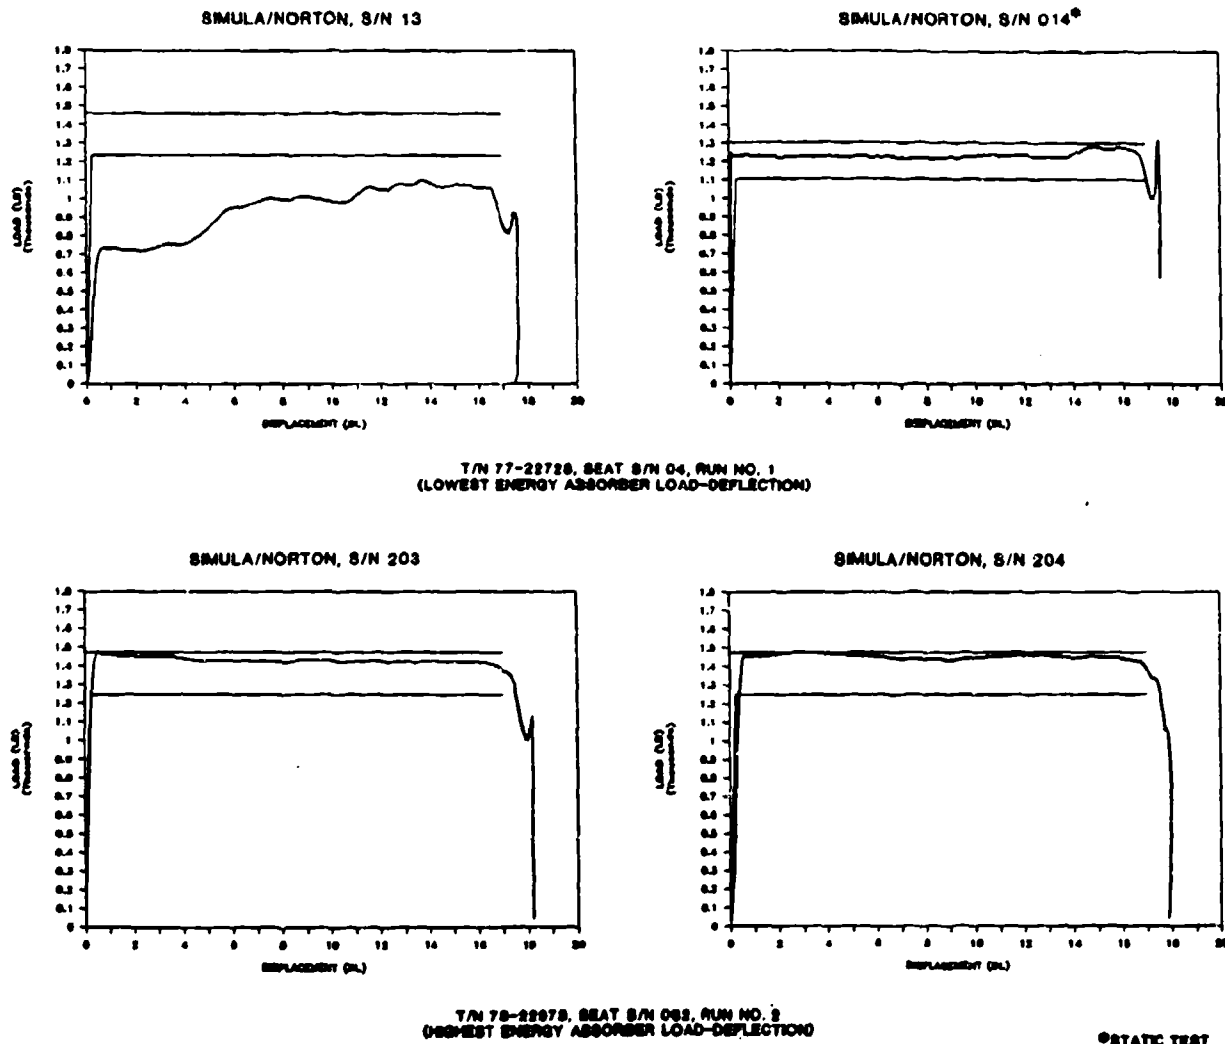
FIGURE 44. SIMULA/NORTON ENERGY ABSORBER LOAD-DEFLECTION CHARACTERISTICS FOR SOM-LA MODELS.

Three seats were modeled, as shown in Table 18. The energy absorber load-deflection characteristics are shown in Figure 44. The model results are shown in Table 19 and Figure 45. Note that the seat with the lowest energy absorber loads would have required approximately 3.7 in. more stroke as compared to the nominal stroking loads.

TABLE 18. SIMULA/NORTON CREW SEATS MODELED WITH PROGRAM SOM-LA

Run No.	Aircraft T/N	Seat S/N	Description
1	77-22728	04	Lowest energy absorber loads
2	78-22973	82	Highest energy absorber loads
3	N/A	N/A	Nominal energy absorber loads

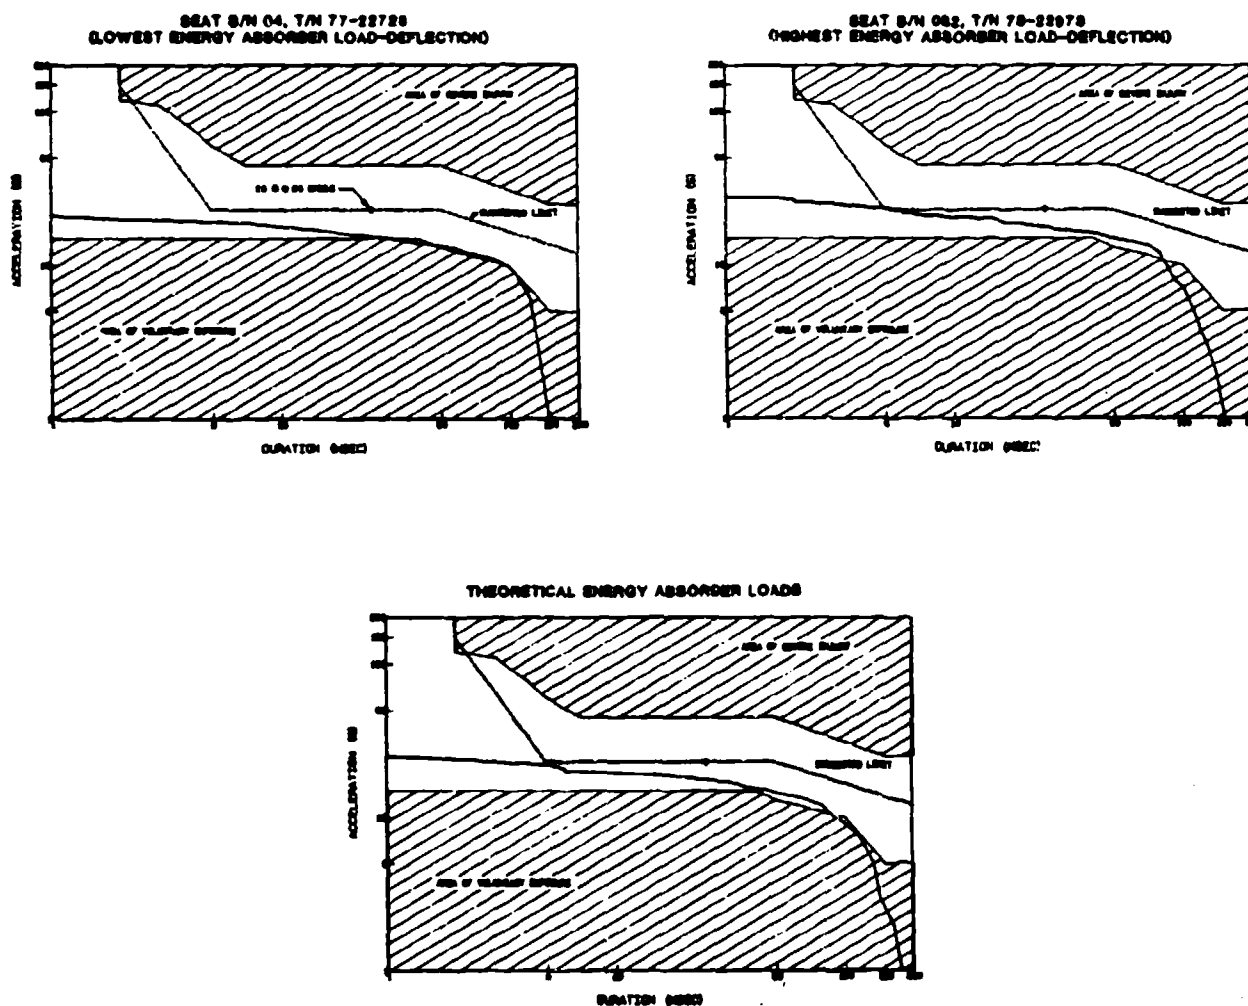
FIGURE 45. EIBAND PLOTS FOR SIMULA/NORTON SON-LA MODEL PELVIS VERTICAL ACCELERATION.

TABLE 19. SIMULA/NORTON SON-LA MODEL RESULTS

Run No.	Maximum DRJ	Maximum Spinal Load (lb)	Vertical Stroke (in.)	Description
1	16.0	1529	16.37	Lowest energy absorber loads
2	19.6	2124	11.02	Highest energy absorber loads
3	18.4	1950	12.65	Nominal energy absorber loads

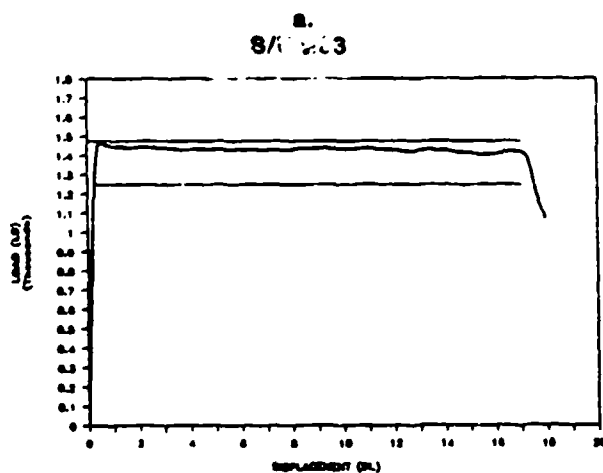
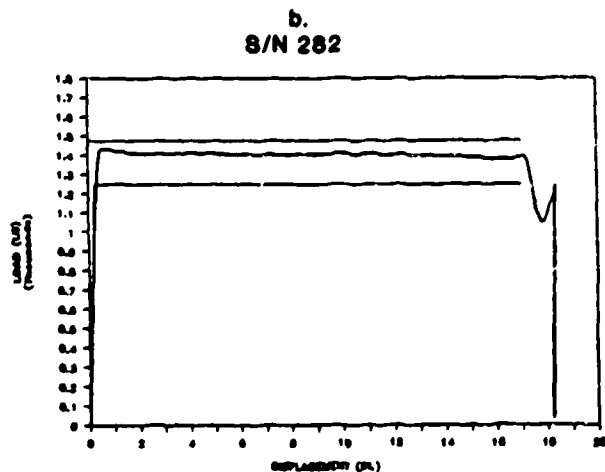
FIGURE D-8. SIMULA/NORTON SEAT S/N \*, AIRCRAFT T/N 78-22990.

\*Name placard missing.

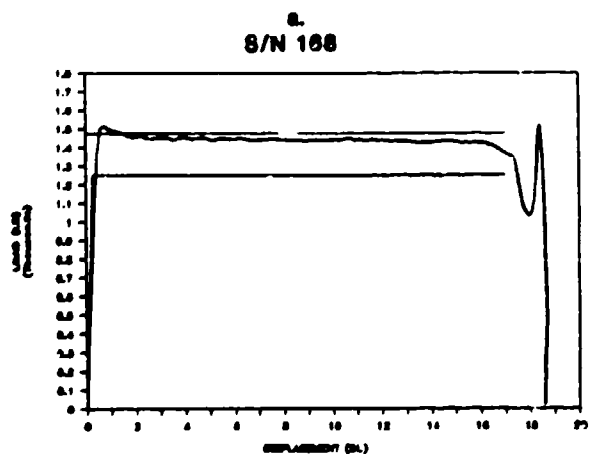
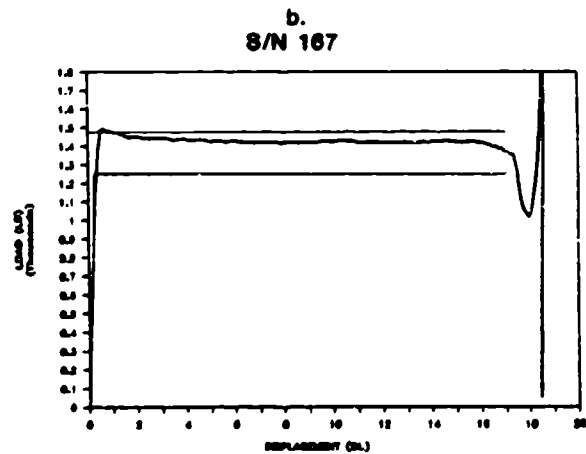
FIGURE D-10. SIMULA/NORTON SEAT S/N 064, AIRCRAFT T/N 78-22991.

SEAT TYPE AND SERIAL NUMBER: <u>PILOT</u> <u>COPILOT</u> <div style="float: right; border: 1px solid black; padding: 2px; margin-top: -10px;">S/N 0064</div>					
<b>SEAT CONDITION (GENERAL WEAR, CORROSION, FOD, ETC.)</b> Good - no evidence of corrosion, cushions ok.						
<b>SEAT ENVIRONMENT (OBJECTS ATTACHED, PAINT, OIL, ETC.)</b> Generally good - as above.						
<b>ENERGY ABSORBER CONDITION</b> <table style="width: 100%;"> <tr> <td style="width: 50%;">ENVIRONMENT</td> <td style="width: 50%;">INSTALLATION</td> </tr> <tr> <td colspan="2">Generally good - as above.</td> </tr> </table>			ENVIRONMENT	INSTALLATION	Generally good - as above.	
ENVIRONMENT	INSTALLATION					
Generally good - as above.						
<b>ENERGY ABSORBER IDENTIFICATION (ASSIGN NUMBER TO EACH E/A)</b> <table style="width: 100%; border-collapse: collapse;"> <tr> <td style="width: 30%;">SIDE OF SEAT</td> <td style="width: 70%; border-bottom: 1px solid black;">RH 00168</td> </tr> <tr> <td></td> <td style="border-bottom: 1px solid black;">LH 00167</td> </tr> </table>			SIDE OF SEAT	RH 00168		LH 00167
